**Flood Control Project Maintenance
Levee Inspections**

Fall 2016 Levee Maintenance Deficiency Summary Report

San Joaquin River Basin

Reclamation District No. 2031 Elliot

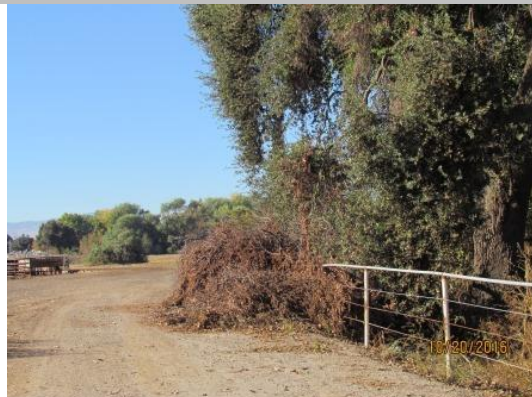
Photo 1 of 3 : FA_2016_RD2031_307_2_20161024_00087.jpg

LM Start	0.48	Rating **	M	Issue No.	2 (cont)
LM End	0.51	Issue Type +	Ma	Location *	WS

View of the large tree branch on the waterside levee slope. Fall 2016

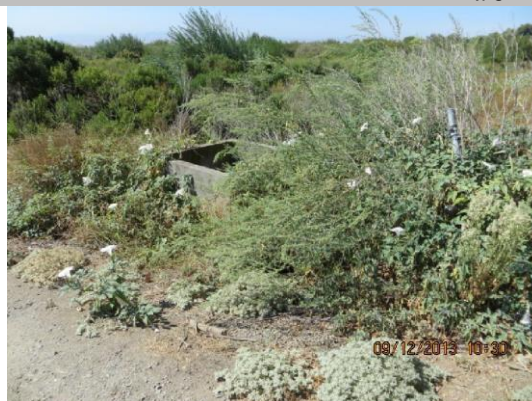
Photo 1 of 2 : UCIP_FA_2016_20667_34750.jpg

LM Start	3.69	Rating **	M	Issue No.	991 (cont)
LM End	3.69	Issue Type +	En	Location *	LS

Concrete distribution box on LS slope.

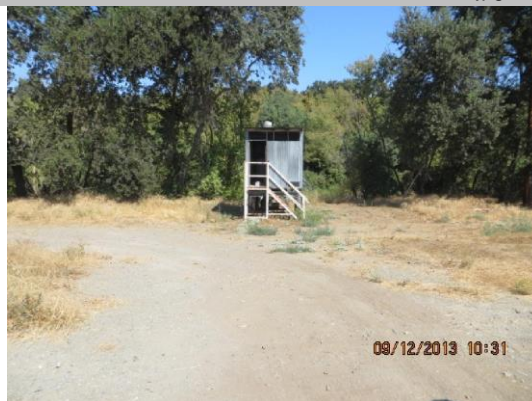
Photo 1 of 2 : UCIP_FA_2016_22845_39021.jpg

LM Start	3.69	Rating **	M	Issue No.	993 (cont)
LM End	3.69	Issue Type +	En	Location *	LS

Pipe visible on WS of pumphouse.

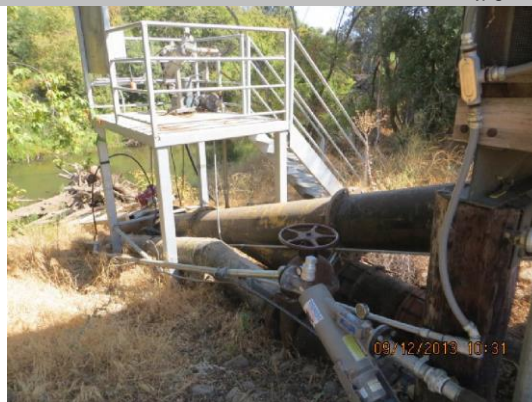
Photo 2 of 2 : UCIP_FA_2016_22845_39020.jpg

Pipe and appurtenances visible on downstream side of and next to larger irrigation pipe.

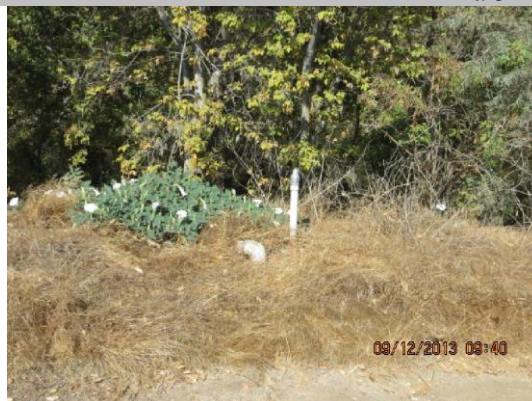
Photo 1 of 2 : UCIP_FA_2016_22846_39023.jpg

LM Start	4.40	Rating **	M	Issue No.	994
LM End	4.40	Issue Type +	En	Location *	LS
Category	Supplemental			GPS Latitude/Longitude	
				Start	End
Item	DWR UCIP Field Study			37.686500 °	37.686500 °
				-121.207900 °	-121.207900 °
DWR ID					
Comment Code					
Inspector Comment					
FS_ID:22846 DS_ID:24673 EP_NO: N/A Repair Type: Non-Urgent Crossing Status: Found UCIP Comments: No permit identified for this possible crossing. FIELD_STRUCT_DESC: 4-inch galvanized iron irrigation line visible on WS shoulder. May go through the levee at unknown depth. Vent on WS shoulder. FS Date: 9/12/2013

Pipe and vent visible on WS shoulder.

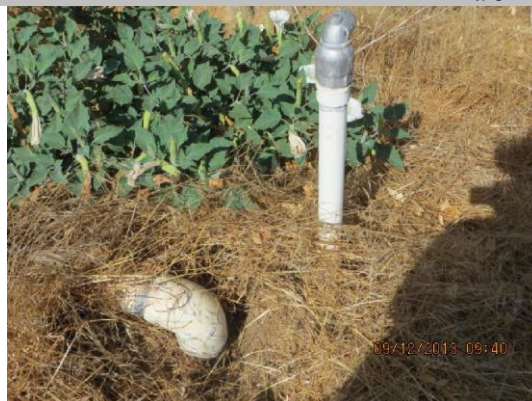
Photo 2 of 2 : UCIP_FA_2016_22846_39022.jpg

LM Start	4.40	Rating **	M	Issue No.	994 (cont)
LM End	4.40	Issue Type +	En	Location *	LS
Category	Supplemental			GPS Latitude/Longitude	
				Start	End
Item	DWR UCIP Field Study			37.686500 °	37.686500 °
				-121.207900 °	-121.207900 °
DWR ID					
Comment Code					
Inspector Comment					
FS_ID:22846 DS_ID:24673 EP_NO: N/A Repair Type: Non-Urgent Crossing Status: Found UCIP Comments: No permit identified for this possible crossing. FIELD_STRUCT_DESC: 4-inch galvanized iron irrigation line visible on WS shoulder. May go through the levee at unknown depth. Vent on WS shoulder. FS Date: 9/12/2013

Pipe and vent visible on WS shoulder.

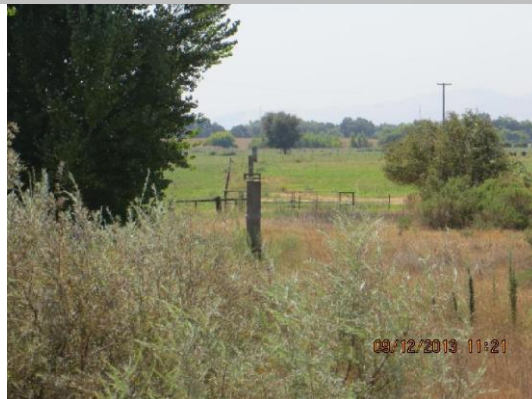
Photo 1 of 2 : UCIP_FA_2016_20688_34799.jpg

LM Start	4.97	Rating **	M	Issue No.	983 (cont)
LM End	4.97	Issue Type +	En	Location *	LS

Concrete standpipes visible in field off LS toe.

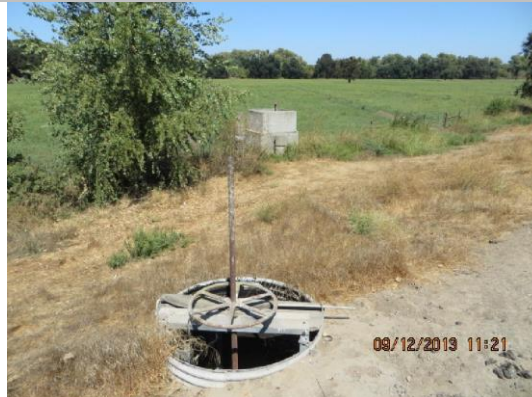
Photo 2 of 2 : UCIP_FA_2016_20688_34798.jpg

Slide gate in CMP riser on WS shoulder with concrete distribution box visible in background at WS toe.

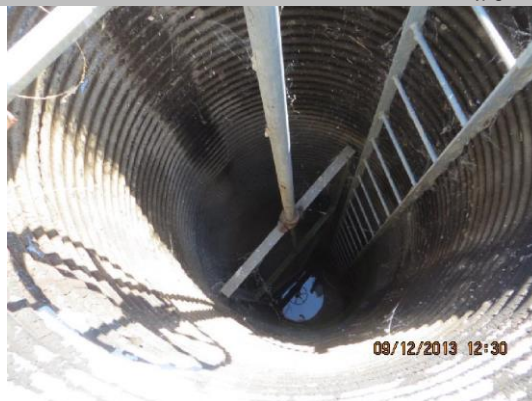
Photo 1 of 2 : UCIP_FA_2016_20708_34834.jpg

LM Start	0.24	Rating **	M	Issue No.	967 (cont)
LM End	0.24	Issue Type +	En	Location *	WS

Slide gate in CMP riser on WS slope.

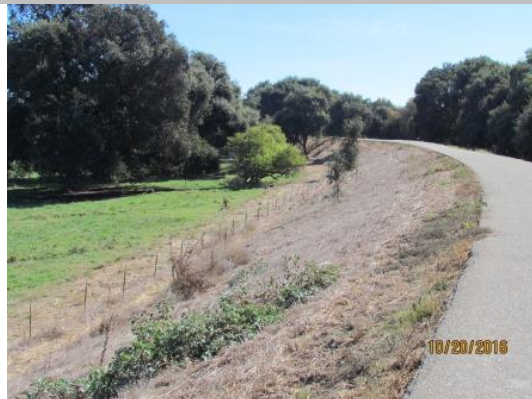
Photo 1 of 1 : FA_2016_RD2031_308_16_20161024_00033.jpg

LM Start	0.46	Rating **	A	Issue No.	16
LM End	0.76	Issue Type +	Ma	Location *	LS
Category	Earthen Levee			GPS Latitude/Longitude	
				Start	End
Item	Vegetation			37.655679 °	37.653843 °
				-121.234410 °	-121.229365 °
DWR ID	DWR_RD2031_02_f_2016_16				
Comment Code					
V1 : Control annual grass and weeds on the levee slopes and easements.					
Inspector Comment					
No unwanted vegetation on levee slope.

View of acceptable vegetation control on the levee slope.

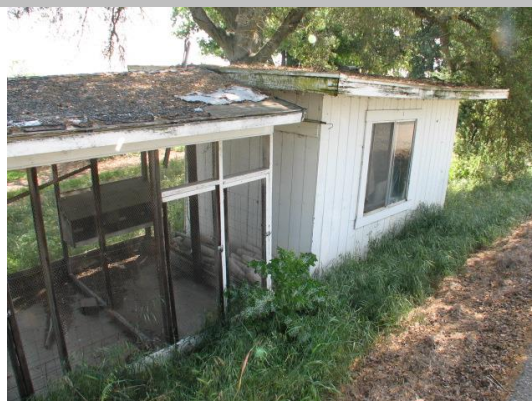
Photo 1 of 1 : FA_2016_RD2031_308_4_20160914_00004.jpg

LM Start	1.35	Rating **	U	Issue No.	4
LM End	1.35	Issue Type +	En	Location *	LS
Category	Earthen Levee			GPS Latitude/Longitude	
				Start	End
Item	Encroachments			37.648898 °	37.648898 °
				-121.221621 °	-121.221621 °
DWR ID	DWR_RD2031_02_s_2012_4				
Comment Code					
BU : Building					
Inspector Comment

Small structure on levee slope.

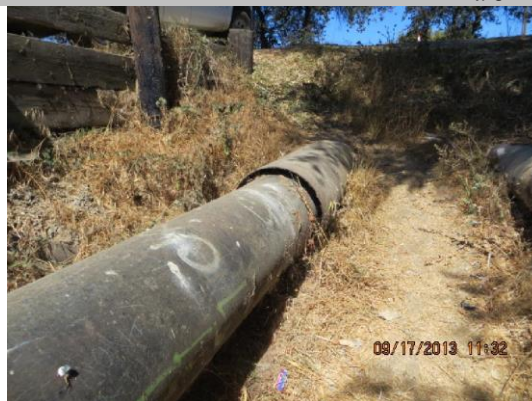
Photo 1 of 2 : UCIP_FA_2016_20719_34860.jpg

LM Start	3.21	Rating **	M	Issue No.	970
LM End	3.21	Issue Type +	En	Location *	LS
Category	Supplemental			GPS Latitude/Longitude	
				Start	End
Item	DWR UCIP Field Study			37.638185 °	37.638185 °
				-121.202906 °	-121.202906 °
DWR ID					
Comment Code					
Inspector Comment					
FS_ID:20719 DS_ID:20492 EP_NO: N/A Repair Type: Non-Urgent Crossing Status: Found UCIP Comments: Annular space between 20-inch and 24-inch pipe not grouted. FIELD_STRUCT_DESC: 24-inch steel pipe through levee 8.0 feet below crown. Pump on pile structure in river. 20-inch steel pipe sleeved through 24-inch. 4'X11' concrete distribution box on LS toe. 2-inch electrical conduit at same location. Originally included in the 1968 O&M manual. FS Date: 9/17/2013

24-inch with 20-inch sleeved through it.

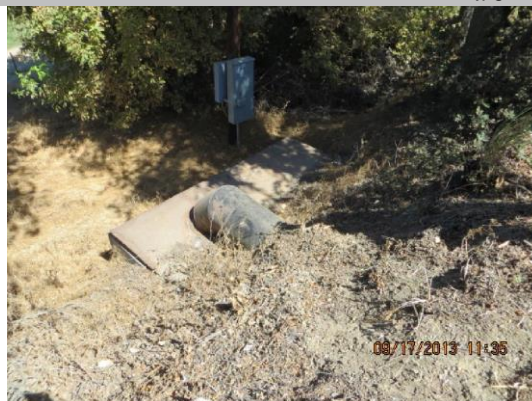
Photo 2 of 2 : UCIP_FA_2016_20719_34859.jpg

LM Start	3.21	Rating **	M	Issue No.	970 (cont)
LM End	3.21	Issue Type +	En	Location *	LS
Category	Supplemental			GPS Latitude/Longitude	
				Start	End
Item	DWR UCIP Field Study			37.638185 °	37.638185 °
				-121.202906 °	-121.202906 °
DWR ID					
Comment Code					
Inspector Comment					
FS_ID:20719 DS_ID:20492 EP_NO: N/A Repair Type: Non-Urgent Crossing Status: Found UCIP Comments: Annular space between 20-inch and 24-inch pipe not grouted. FIELD_STRUCT_DESC: 24-inch steel pipe through levee 8.0 feet below crown. Pump on pile structure in river. 20-inch steel pipe sleeved through 24-inch. 4'X11' concrete distribution box on LS toe. 2-inch electrical conduit at same location. Originally included in the 1968 O&M manual. FS Date: 9/17/2013

Concrete distribution box on LS slope.

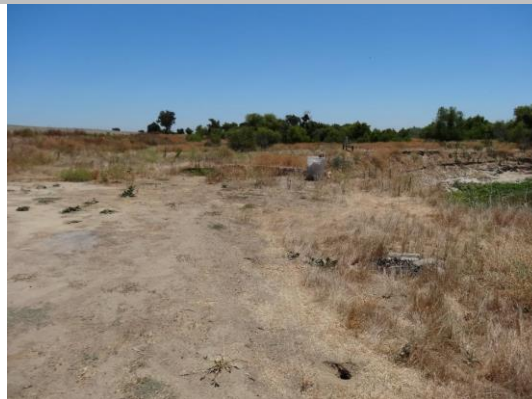
Photo 1 of 3 : SJR2016_RD2031U02RM78.7_1.jpg

LM Start	4.29	Rating **	A/W	Issue No.	1 (cont)
LM End	4.33	Issue Type +	Ma	Location *	WS

Looking downstream of the erosion site.

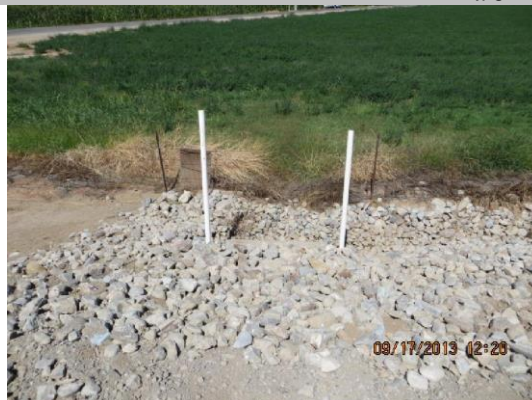
Photo 1 of 2 : UCIP_FA_2016_22872_39036.jpg

LM Start	4.70	Rating **	M	Issue No.	972	
LM End	4.70	Issue Type +	En	Location *	WS	
Category	Supplemental			GPS Latitude/Longitude		
				Start		End
Item	DWR UCIP Field Study			37.630815 °		37.630815 °
				-121.182416 °		-121.182416 °
DWR ID						
Comment Code						
Inspector Comment						
FS_ID:22872						
DS_ID:24676						
EP_NO: N/A						
Repair Type: Non-Urgent						
Crossing Status: Found						
UCIP Comments: No permit identified for this crossing.						
FIELD_STRUCT_DESC: 16-inch PVC irrigation pipe through the levee						
6-feet below the crown. Headwall on LS toe.						
FS Date: 9/17/2013

Concrete headwall at outlet on LS toe.

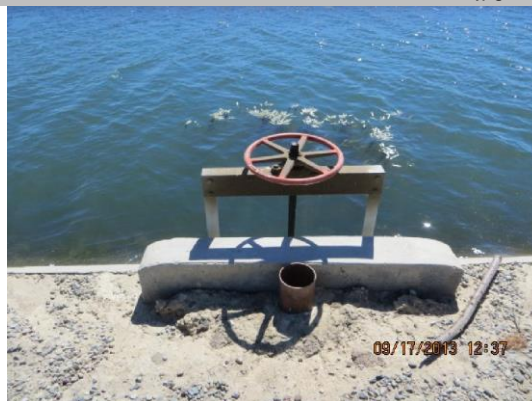
Photo 2 of 2 : UCIP_FA_2016_22873_39037.jpg

LM Start	5.63	Rating **	M	Issue No.	973 (cont)
LM End	5.63	Issue Type +	En	Location *	WS
Category	Supplemental			GPS Latitude/Longitude	
				Start	End
Item	DWR UCIP Field Study			37.630779 °	37.630779 °
				-121.165402 °	-121.165402 °
DWR ID					
Comment Code					
Inspector Comment					
FS_ID:22873 DS_ID:24677 EP_NO: N/A Repair Type: Non-Urgent Crossing Status: Found UCIP Comments: No permit identified for this crossing. FIELD_STRUCT_DESC: 24-inch PVC irrigation pipeline through levee 5.0-feet below crown. Slide gate at waterward shoulder. 6-inch steel riser on WS shoulder. FS Date: 9/17/2013

Slide gate and vent at concrete headwall on canal at WS shoulder.

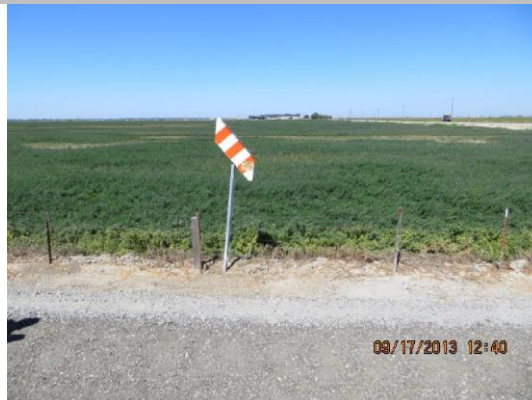
Photo 1 of 2 : UCIP_FA_2016_20745_34961.jpg

LM Start	5.93	Rating **	M	Issue No.	971
LM End	5.93	Issue Type +	En	Location *	WS
Category	Supplemental			GPS Latitude/Longitude	
				Start	End
Item	DWR UCIP Field Study			37.630760 °	37.630760 °
				-121.159951 °	-121.159951 °
DWR ID					
Comment Code					
Inspector Comment					
FS_ID:20745 DS_ID:20503 EP_NO: N/A Repair Type: Non-Urgent Crossing Status: Found UCIP Comments: Gasline may not have enough cover. FIELD_STRUCT_DESC: 8-inch gas line through the levee 1.0-foot below the crown. Originally included in the 1968 O&M manual. Sign on LS toe, pipe visible at canal. FS Date: 9/17/2013

Gasline marker on LS toe.

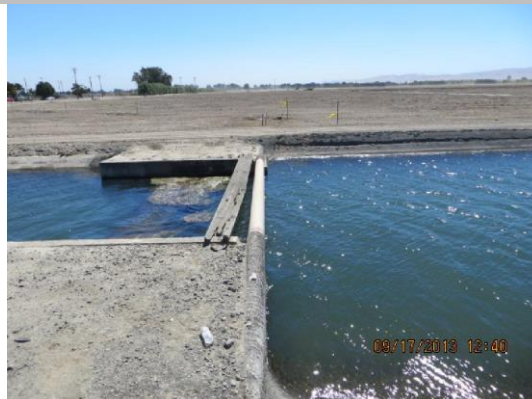
Photo 2 of 2 : UCIP_FA_2016_20745_34960.jpg

LM Start	5.93	Rating **	M	Issue No.	971 (cont)	
LM End	5.93	Issue Type +	En	Location *	WS	
Category	Supplemental			GPS Latitude/Longitude		
				Start	End	
Item	DWR UCIP Field Study			37.630760 °	37.630760 °	
				-121.159951 °	-121.159951 °	
DWR ID						
Comment Code						
Inspector Comment						
FS_ID:20745						
DS_ID:20503						
EP_NO: N/A						
Repair Type: Non-Urgent						
Crossing Status: Found						
UCIP Comments: Gasline may not have enough cover.						
FIELD_STRUCT_DESC: 8-inch gas line through the levee 1.0-foot below the crown. Originally included in the 1968 O&M manual. Sign on LS toe, pipe visible at canal.						
FS Date: 9/17/2013

Gasline visible at crossing.
